# Release Notes for Cisco IOS Release 11.1

**January 11, 1999**

These release notes describe the features and caveats for Cisco IOS Release 11.1 up to and including Release 11.1(24). They include all routing and access server features.

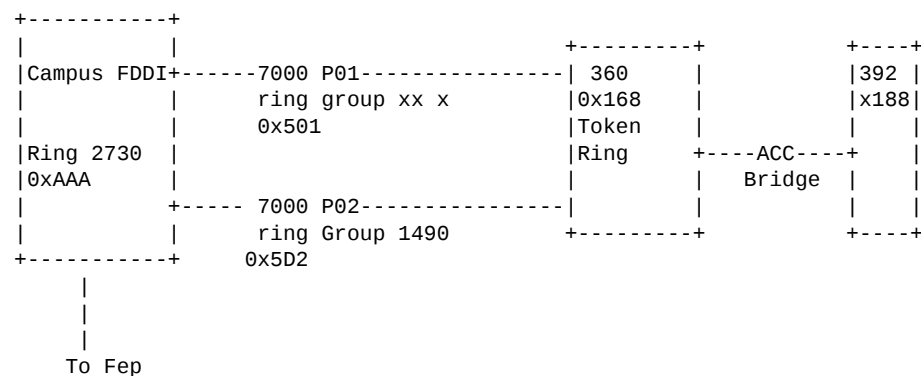
[CSCdj64489]

- A packet loop may occur between Cisco 7000 routers when using FIP cards, connected in the following configuration, while running Cisco IOS Release 11.1(12). No workaround is known.
